# LIVESTOCK AND VEHICULAR UNDERPASSES IN USE

LIVESTOCK AND VEHICULAR UNDERPASSES IN USE --photographic illustrations

RIGHT-OF-WAY SECTION

STATE OF MONTANA - DEPARTMENT OF HIGHWAYS

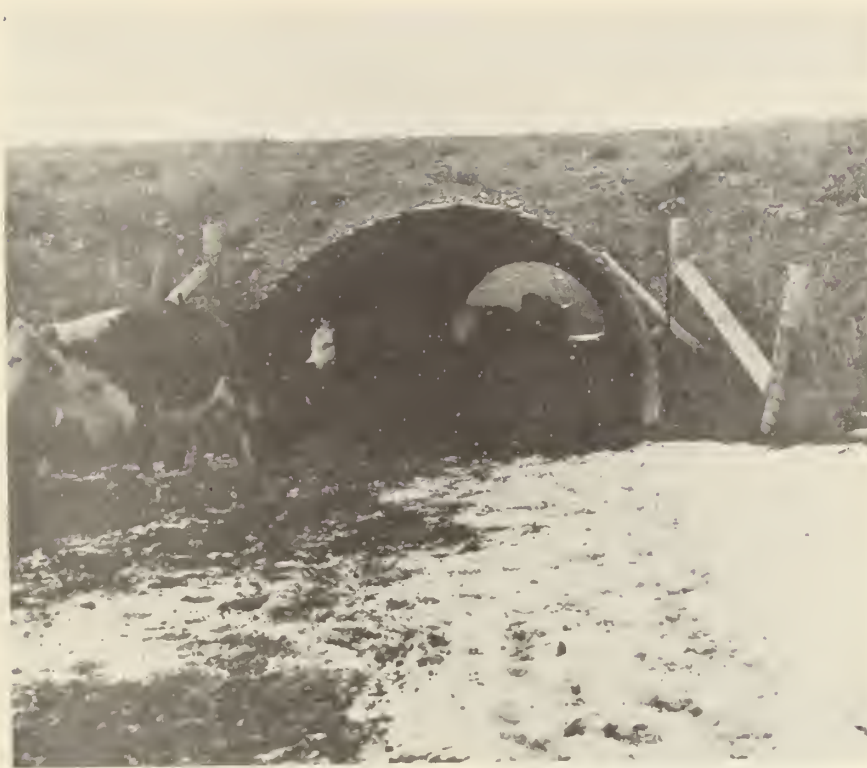
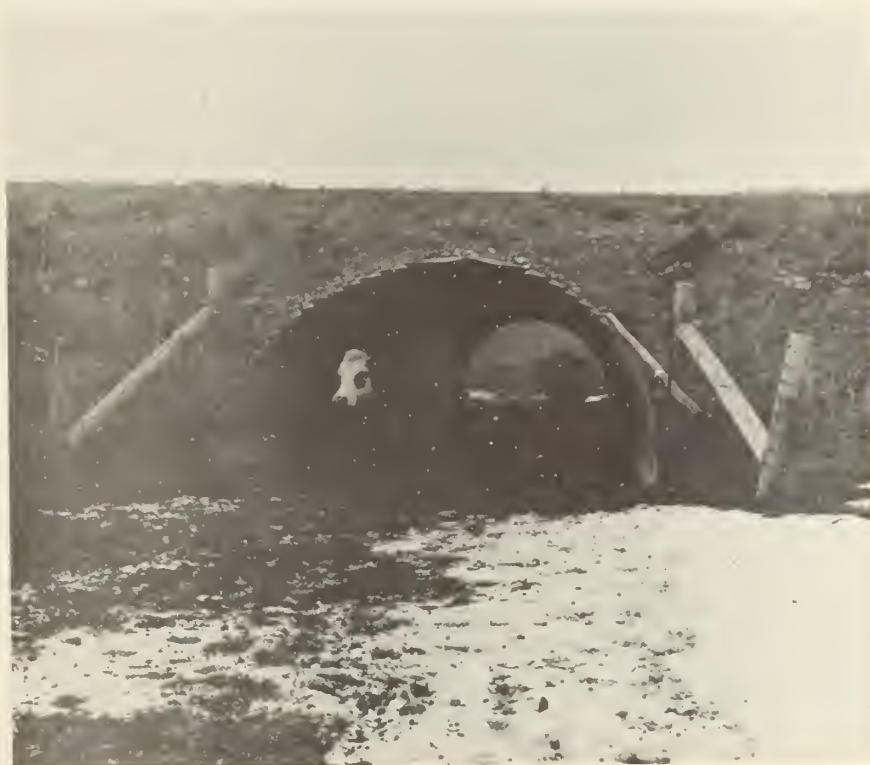
East Exit

12'8" s x 8'7" r x 90' long, Squash C.M.P. Three miles north of Monida Pass under I-15 two-lane. Portion of trail herd shown in these two photos. Very good utility at this time of year for stock drives. Most of these cattle have been through here at least one or two times.

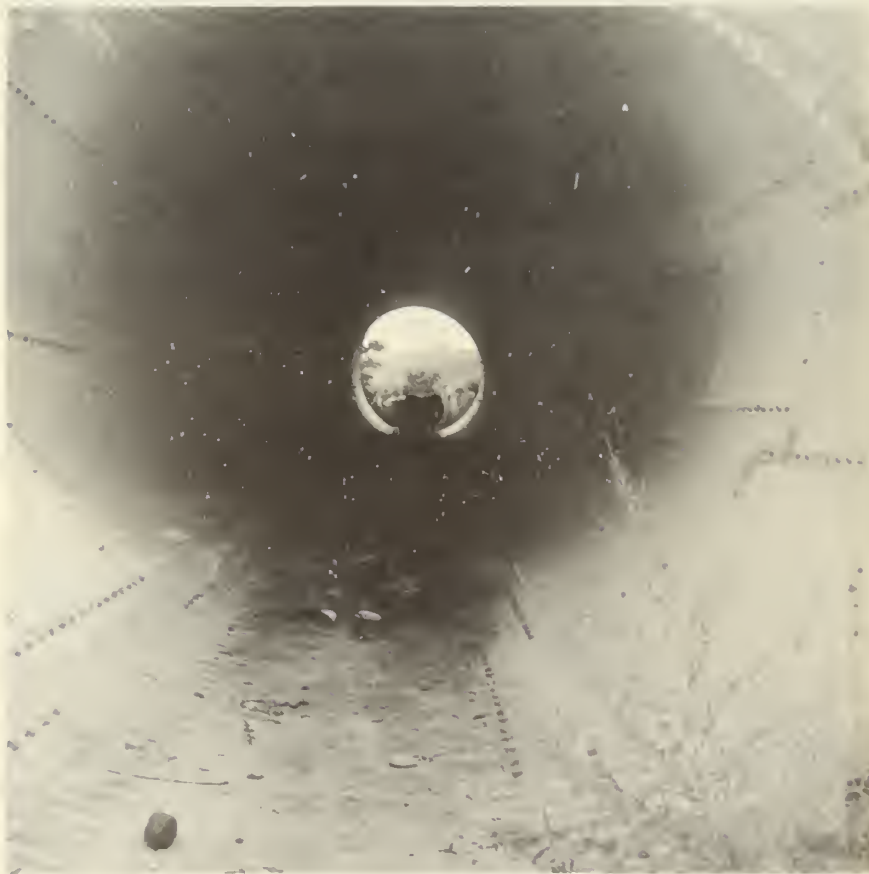
West Exit

156" diameter x 154' long, C.M.P. Just south of junction of I-90 on Highway #287, a two-lane primary route. Thirty head of Hereford cows and some bulls. No surfacing on this pipe, which is also under 22' of fill. Cattle did not seem to hesitate as they started through.

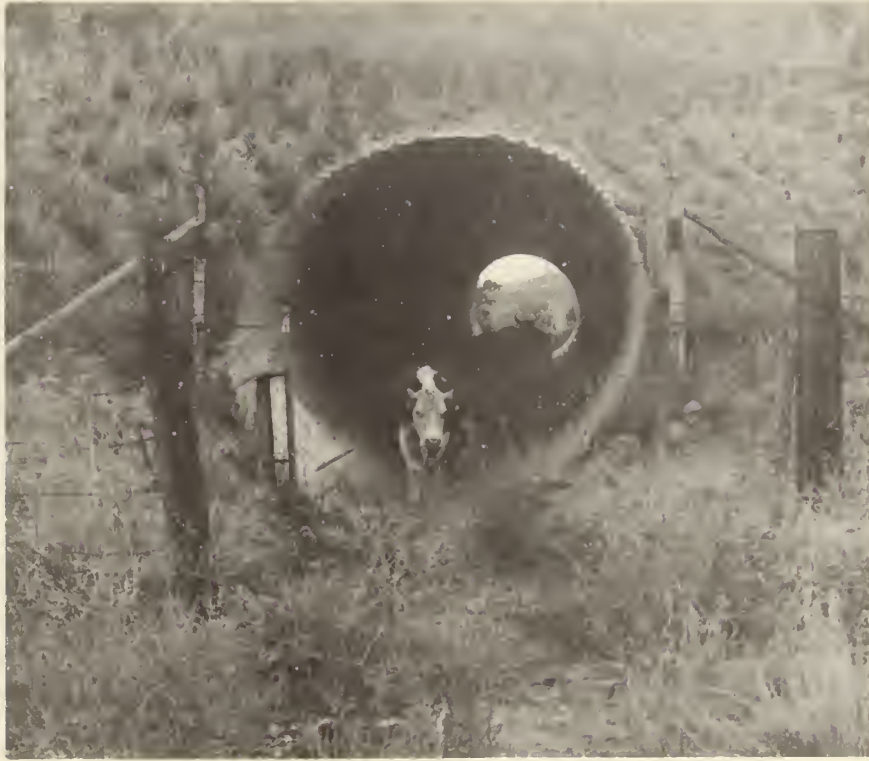
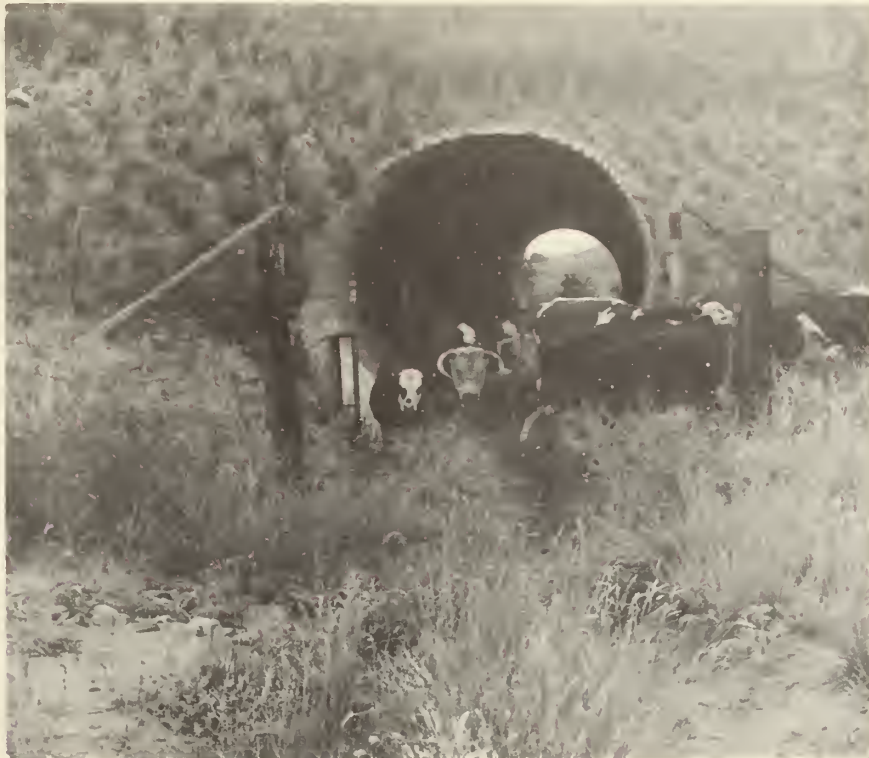
West Exit

156" diameter x 154' long, C.M.P. Just south of junction of I-90 on Highway #287, a two-lane primary route. Thirty head of cows and some bulls. No surfacing on this pipe, however, cattle did not seem to hesitate. There was just enough dirt to provide a walkway.

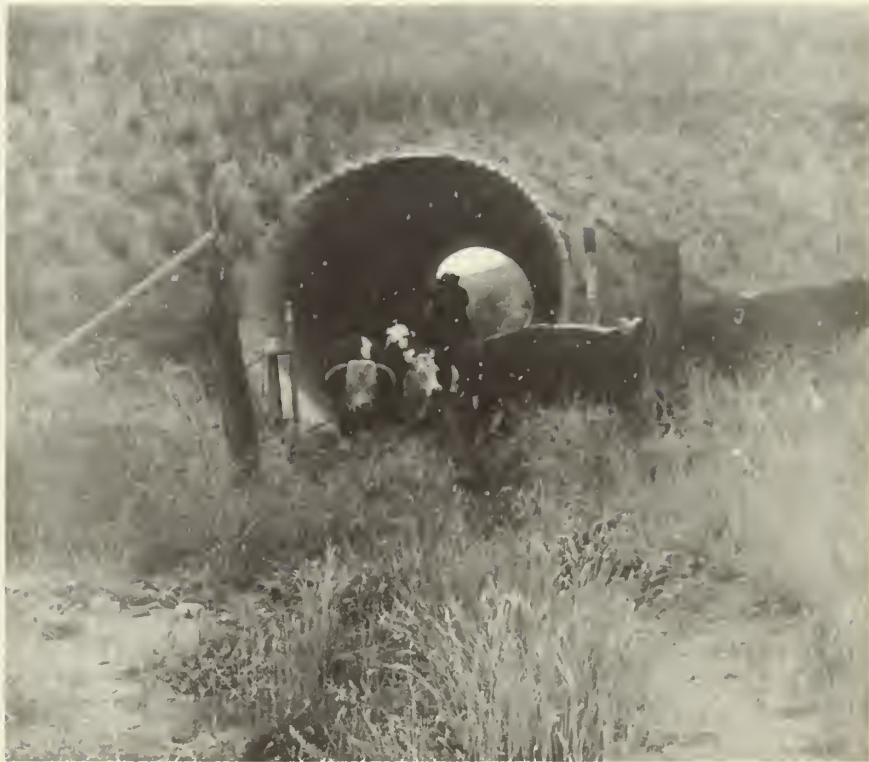
West Exit

156" diameter x 154' long, C.M.P. Just south of junction of I-90 on Highway #287, a two-lane primary route. Thirty head of cows and some bulls. No surfacing, and this is not normally used for vehicle traffic. A 7' wide x 7' high 3/4-ton pickup was placed in the pipe to show size proportions.

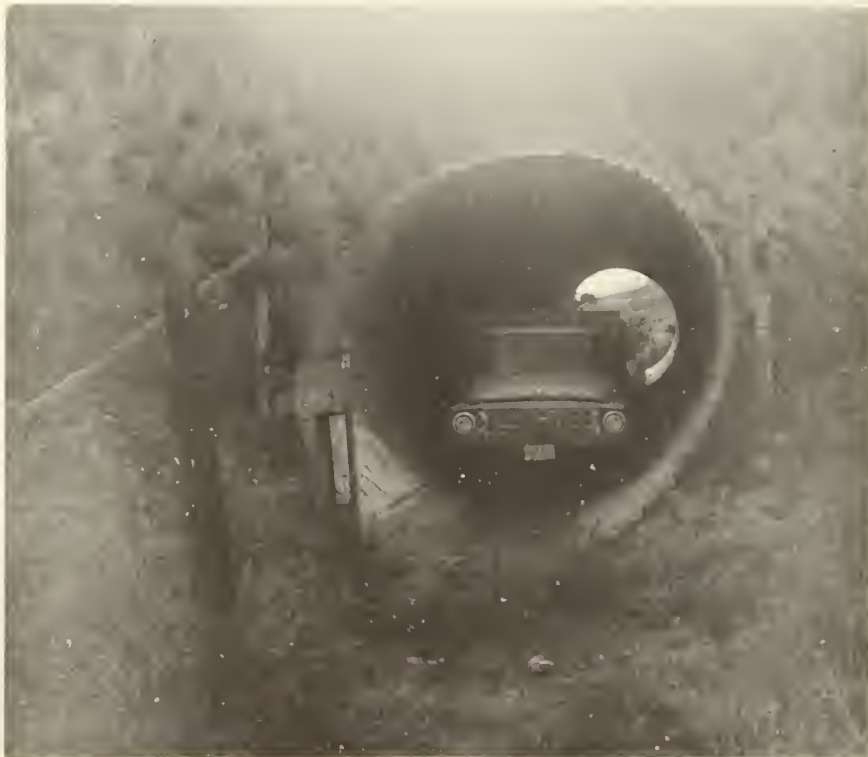
West End - Notice flow measuring device.

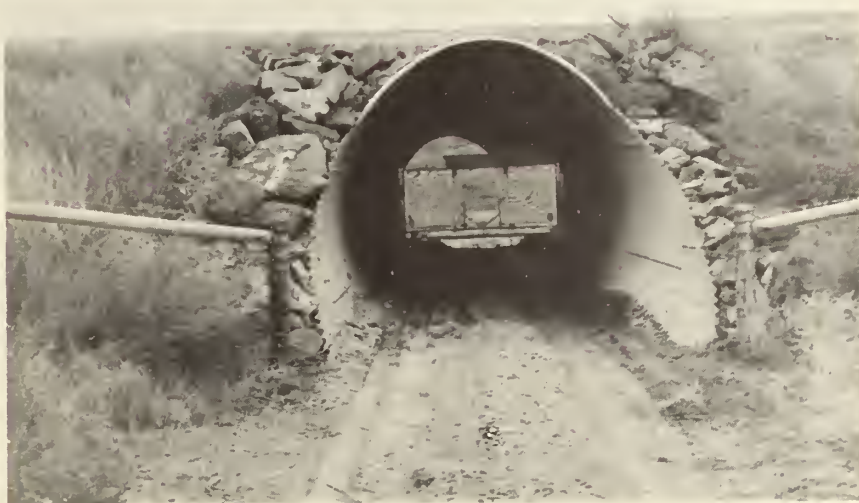
162" diameter x 150' long, C.M.P., set in recessed area east of Hysham under 4-lane 1-94. One and one-half ton grain truck, 7' high x 8' wide; pickup follows.

North End - Low spot is wet and catches drainage.

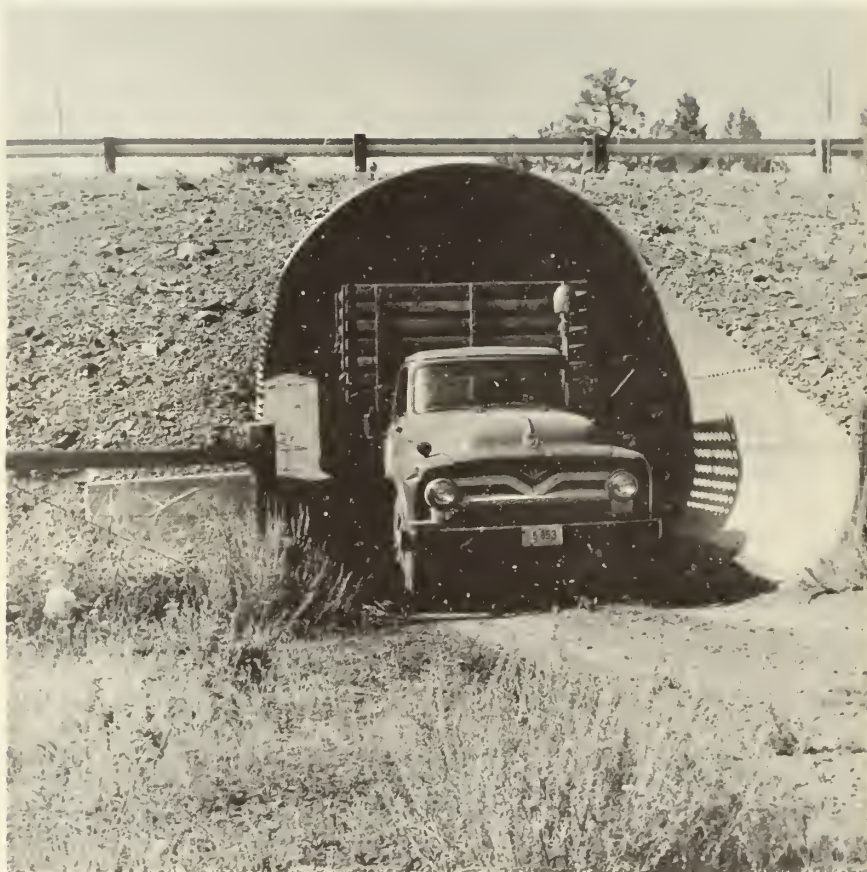
East End of Underpass

15'6''s x 13'10''r x 154' long, Arch C.M.P., Design #180, old Std. Drgs. Seven miles north of Helena under 4-lane highway near Sieben Interchange. One and one-half ton truck with stock rack, 8' wide x 9' high. There is about 10' of roadway width. This is a very good vehicular underpass, also used by logging trucks.

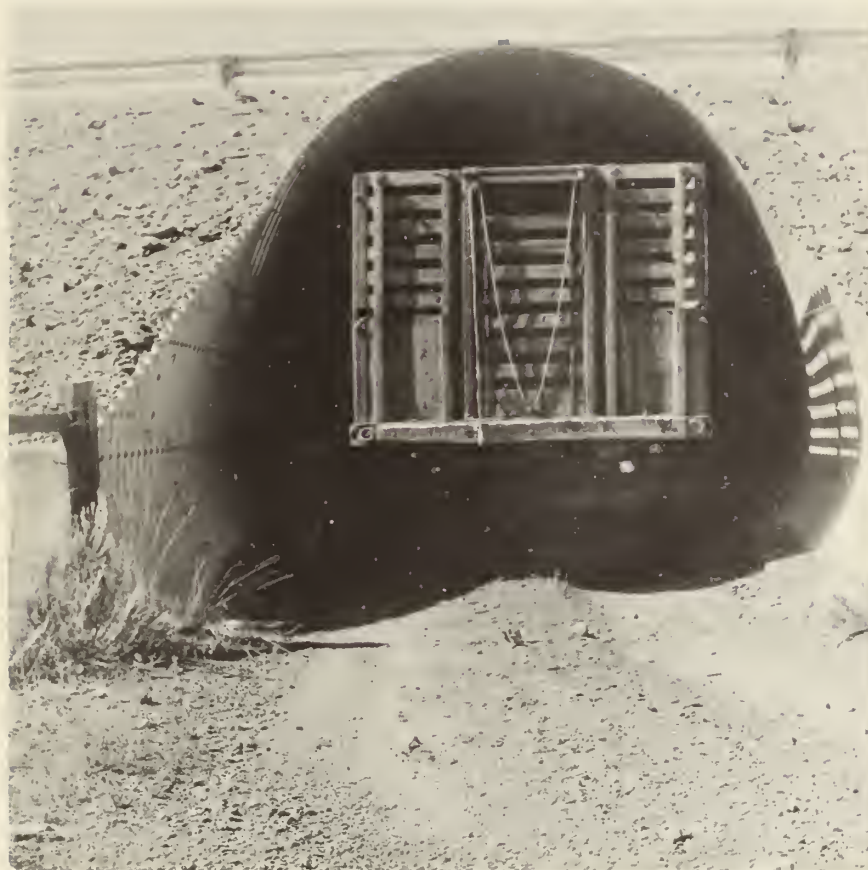
East End of Underpass

15'6''s x 13'10''r x 154' long, Arch C.M.P., Design #180, old Std. Drgs. Seven miles north of Helena, under 4-lane highway near Sieben Interchange. One and one-half ton truck with stock rack, 8' wide x 9' high. There is about 10' of roadway width. This is a very good vehicular underpass, also used by logging trucks.

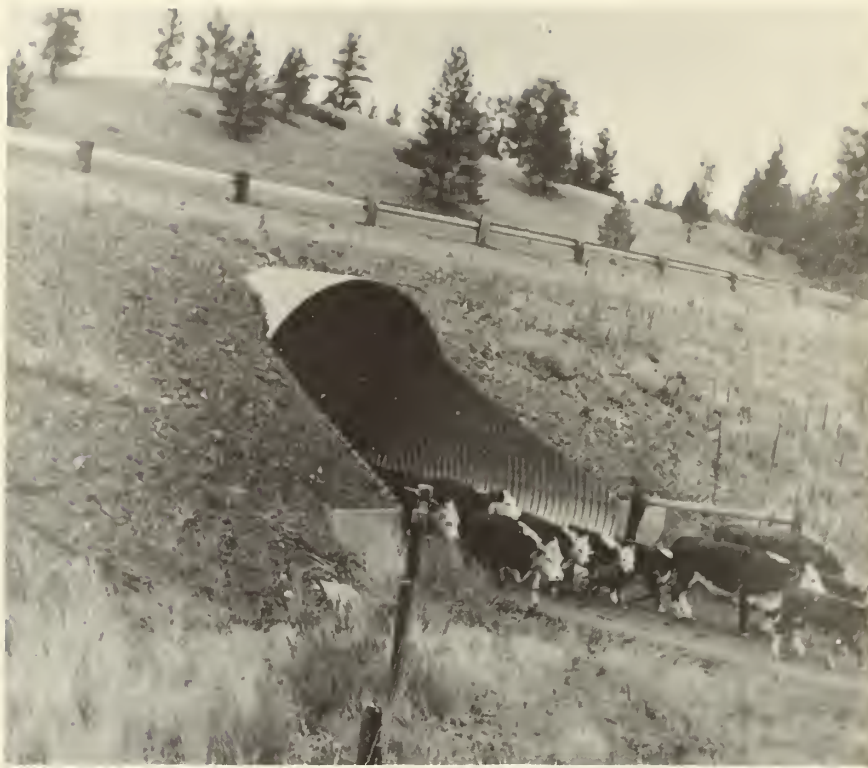
East Exit

15'6" x 13'10" x 154' long, Arch C.M.P., Design #180, old Std. Drgs. Located 7 miles north of Helena under 4-lane highway near Sieben Interchange. Fifty pair (cow with calf) were moved to winter pasture; no hesitation in or through the underpass. The cows (not the calves) had been through before.

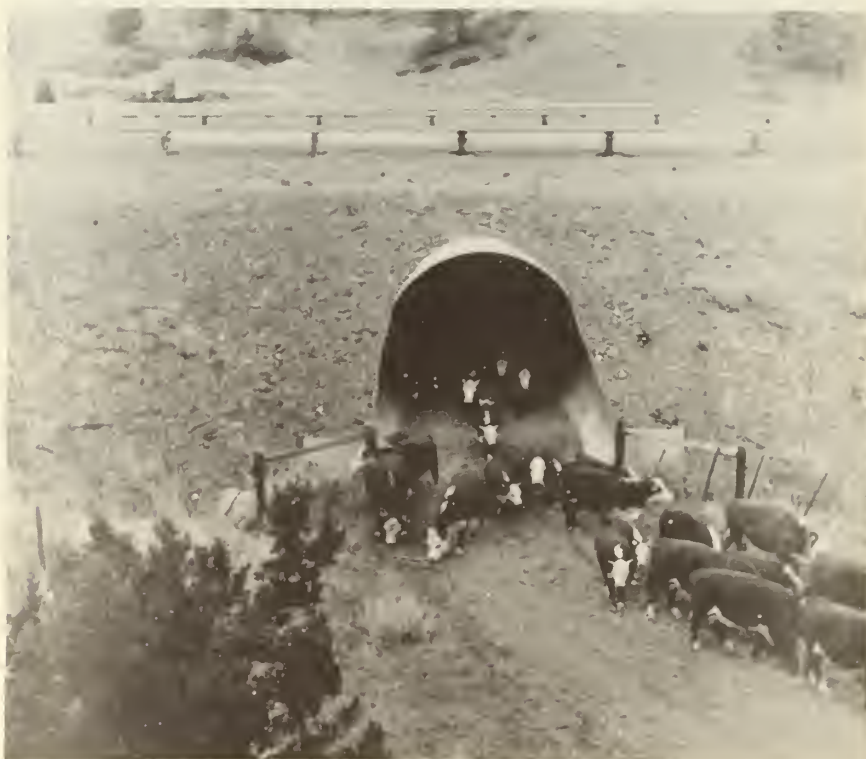
East Exit: Notice wing fencing as per Std. Drg. 81-02

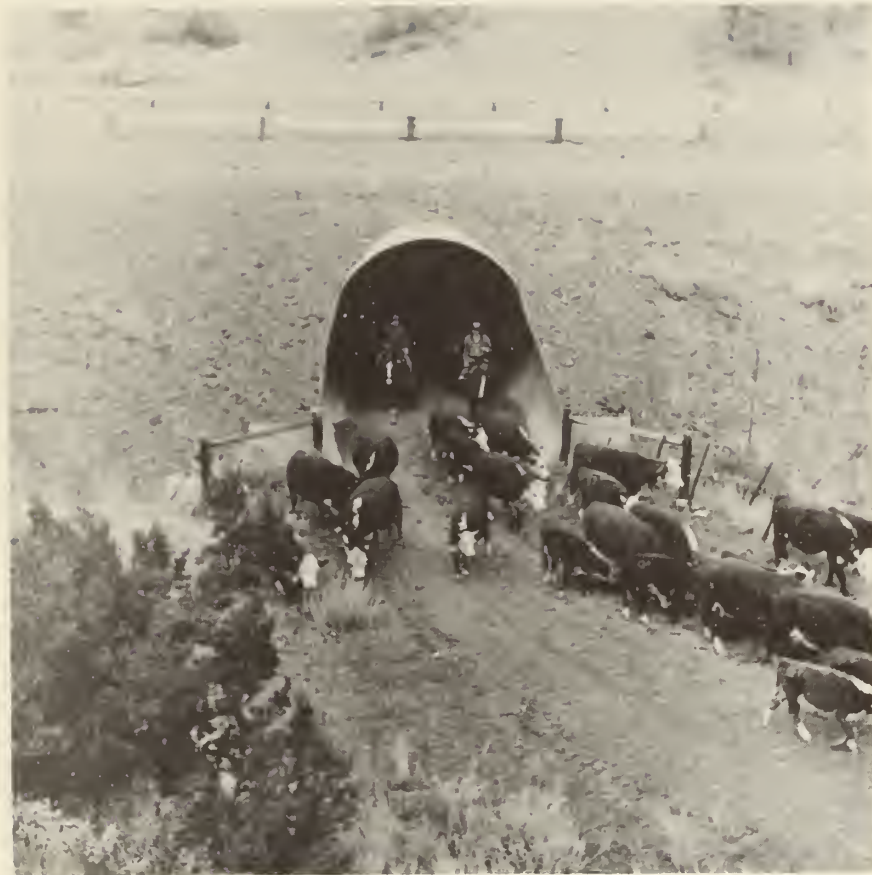
East Exit

15'6''s x 13'10''r x 154' long, Arch C.M.P., Design #180, old Std. Drgs. Located 7 miles north of Helena under 4-lane highway near Sieben Interchange. Fifty pair (cow with calf) moved to winter pasture, no hesitation in or through underpass. Three riders were moving the 100 head of cattle.

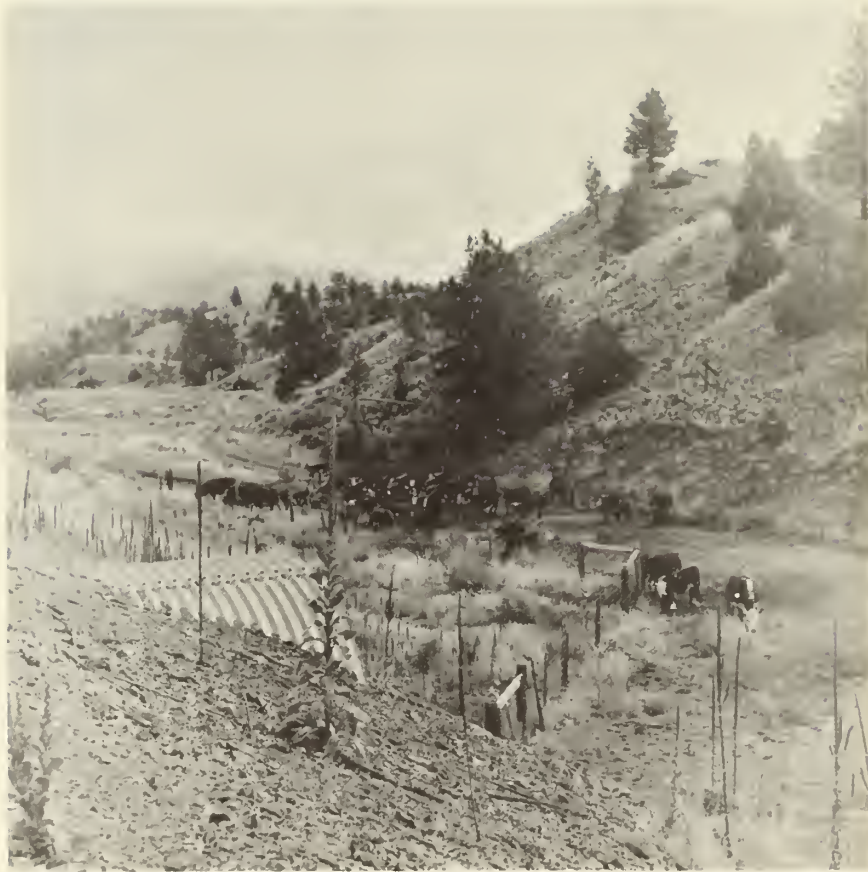
East Exit

15'6''s x 13'10''r x 154' long, Arch C.M.P., Design #180, old Std. Drgs. Located 7 miles north of Helena under 4-lane highway near Sieben Interchange. Fifty pair of Herefords moved to winter pasture, bunched up near gate. Note wing fencing as per Std. Drg. 81-02. The fence angle is about 135°, has reinforced corners and one reinforced section near the pipe. Ideal installation for any size underpass. This is also a very good underpass for cattle or sheep movement. A herd of 5,000 head of sheep are trailed through here once in the springtime.

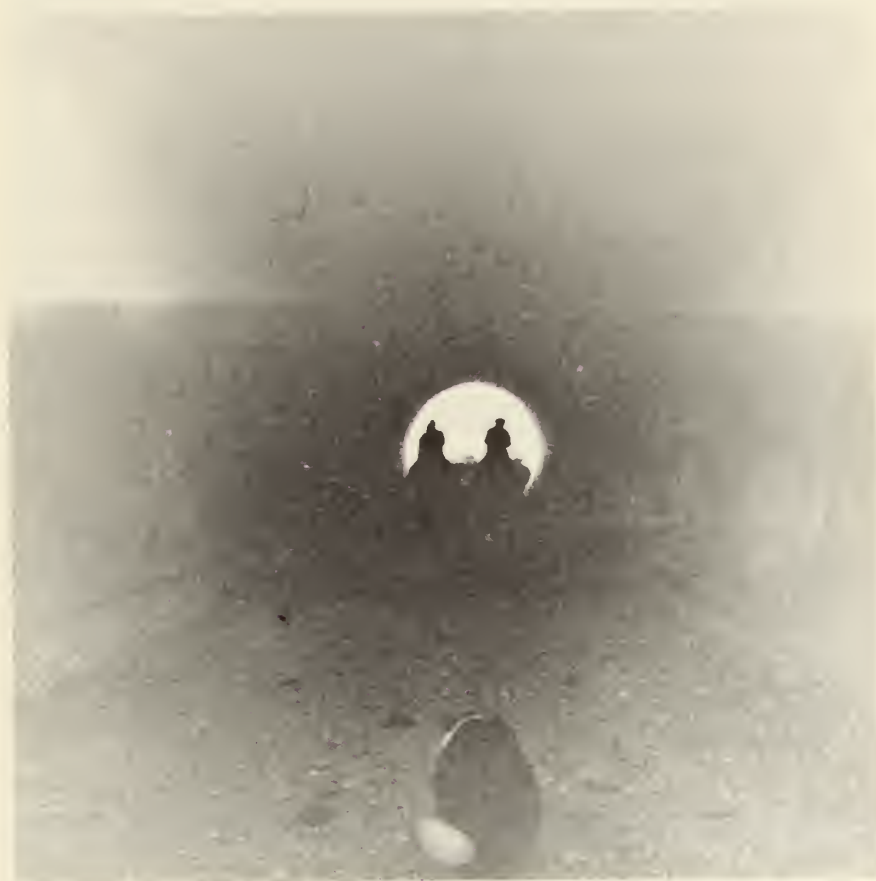
Looking East from West Entrance

180" diameter x 200' long, C.M.P. Three miles north of Lima under 4-lane I-15. Riders following end of 250 head herd movement. Underpass is on county frontage road, therefore, on public thoroughfare. It is a very usable underpass for cattle movement. Notice graveled roadway.

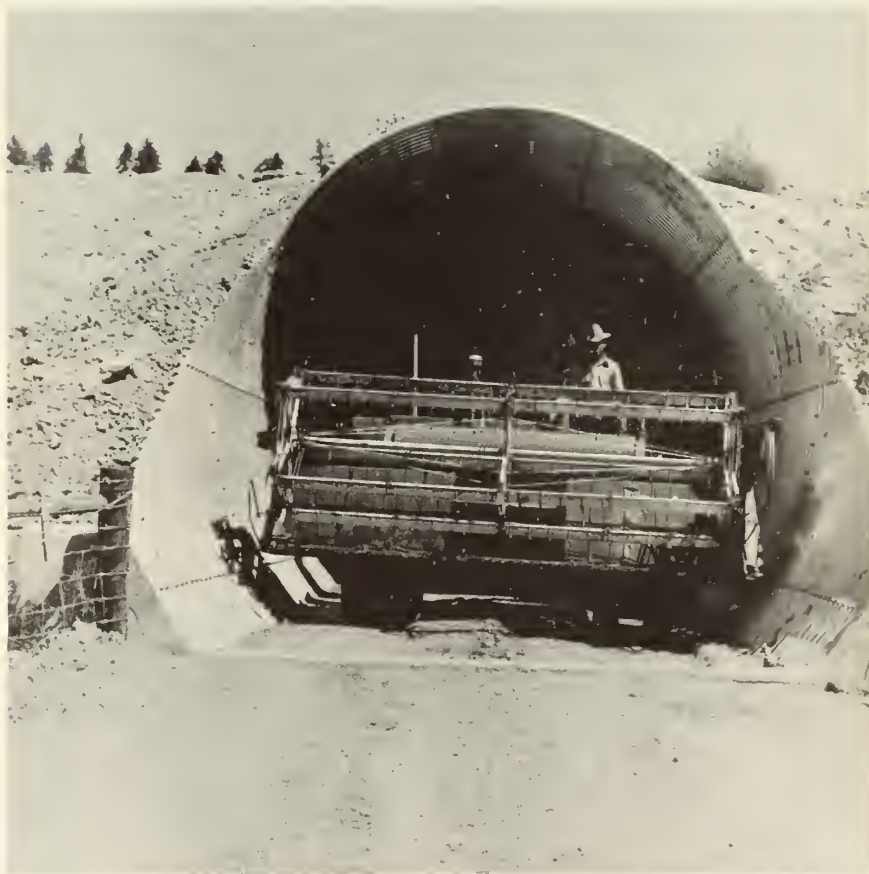
South Entrance

210' diameter (17.5') x 200' long, C.M.P., Std. Drg. 59-06. Three miles west of Columbus, Hesston 300 swather measured 13'6" wide, road bed was 12' wide. This width and depth was just right for the equipment in use in this underpass.

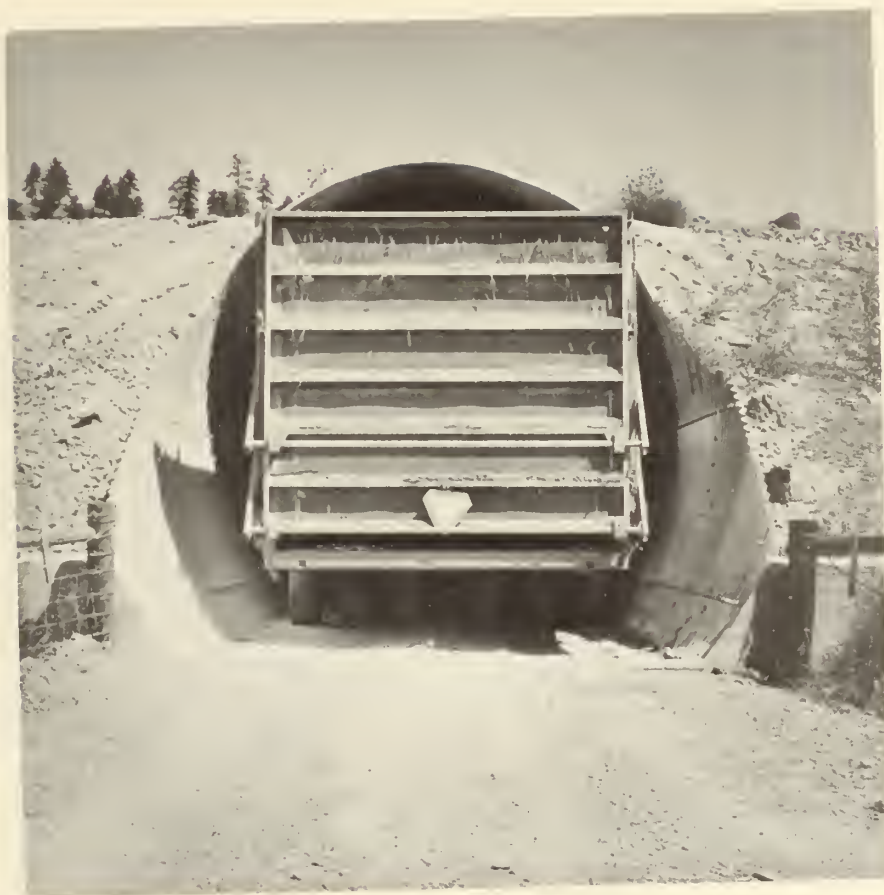
South Entrance

210" diameter (17.5') x 200' long, C.M.P., Std. Drg. 59-06. Three miles west of Columbus. Hesston Stakhand 60 is 11'0" wide x 12'6" high x 30' long. Roadbed is 12' wide. Vehicle moved right through without problems. Roadbed elevation in pipe is at the right level.

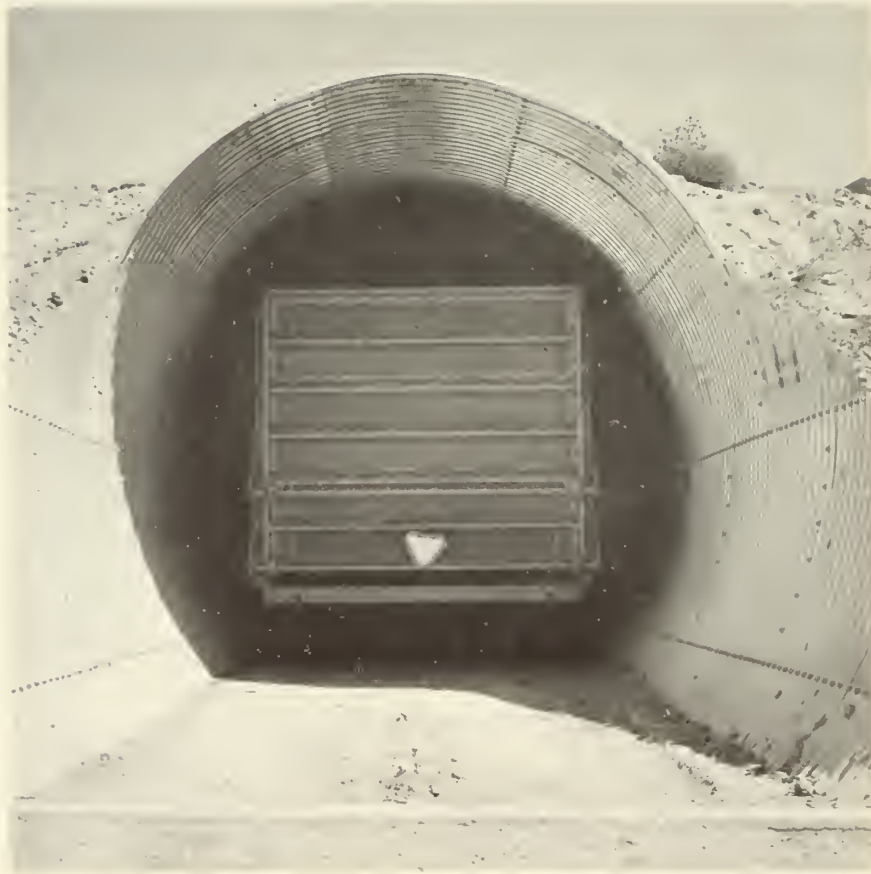
South Entrance

210' diameter (17.5') x 200' long, C.M.P., Std. Drg. 59-06. Three miles west of Columbus. Hesston Stakhand 60 (11'0" wide x 12'6" high x 30' long) continues through with no problem. Roadbed elevation and width in pipe is just right for this equipment.

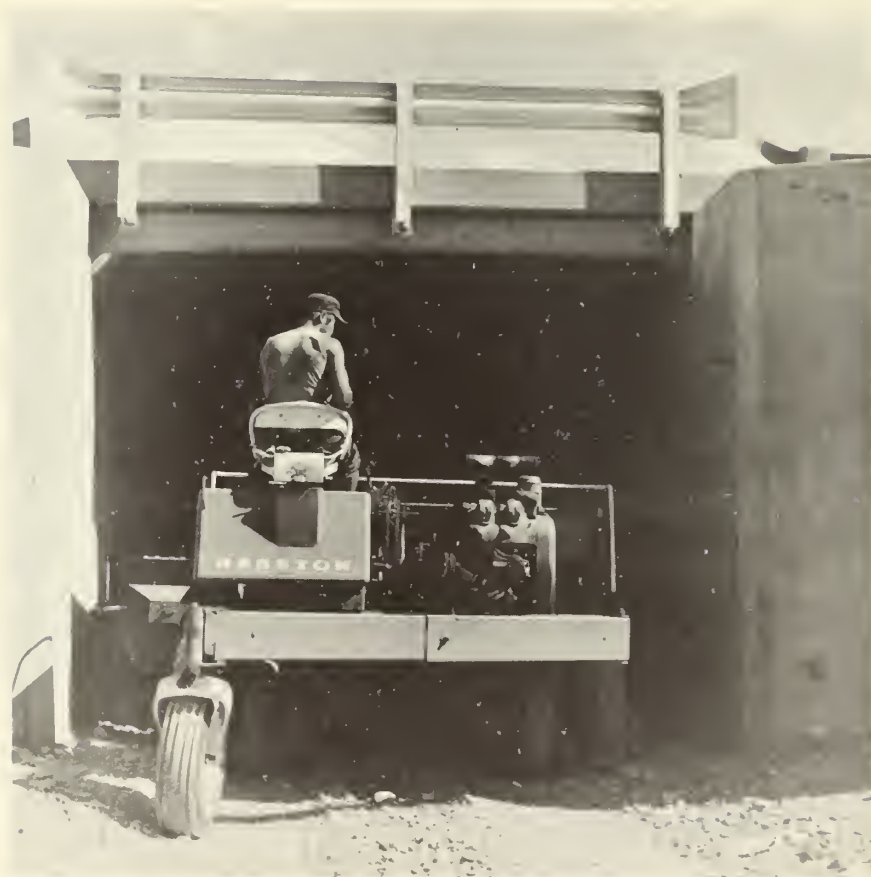
North Entrance

14'6" wide x 11' high x 120' long (actual measurement), reinforced concrete box culvert, Std. Drgs. 41-06, 41-07, 41-08. Location was about two miles east of Livingston. Hesston 500 swather measures 14' in width. Even though clearance was narrow, the driver traveled through at a normal speed. Slab top, dirt bottom in this structure which was located on 4-lane I-90.

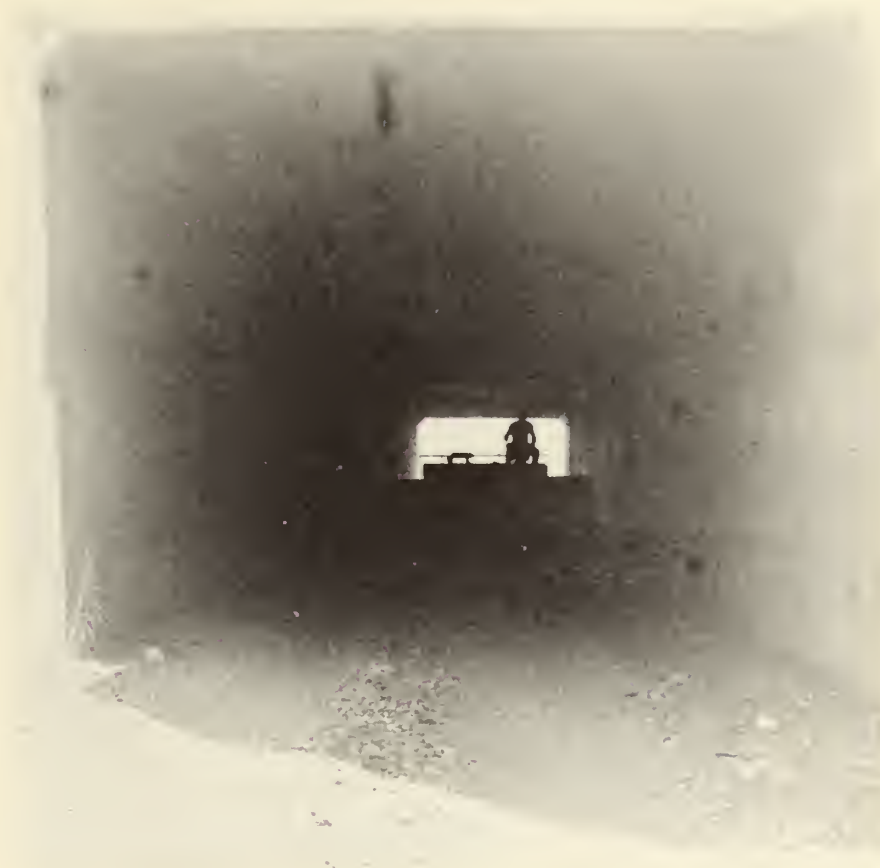
North Entrance

14'6" wide x 11' high x 120' long (actual measurement), reinforced concrete box culvert, Std. Drgs. 41-06, 41-07, 41-08. Location was about two miles east of Livingston under 4-lane I-90. Hesston 500 swather (14' wide) travels on through structure without scraping sides.

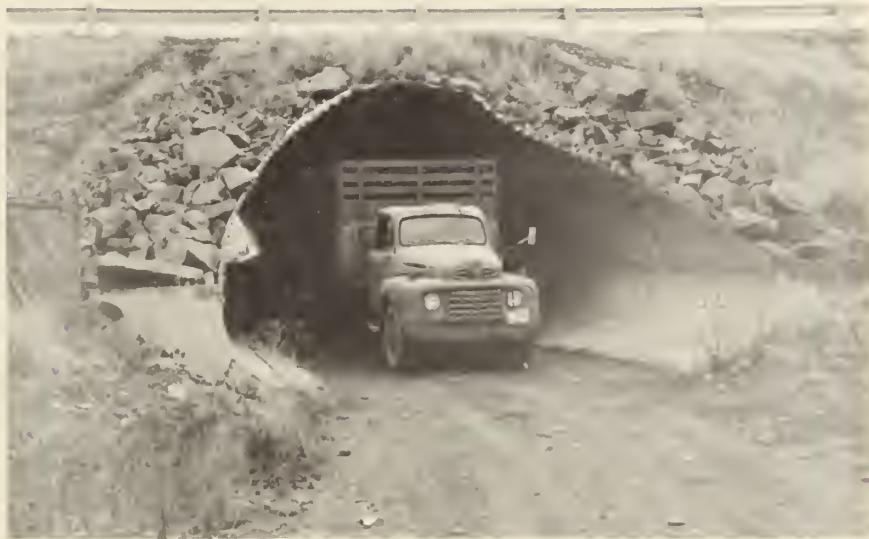
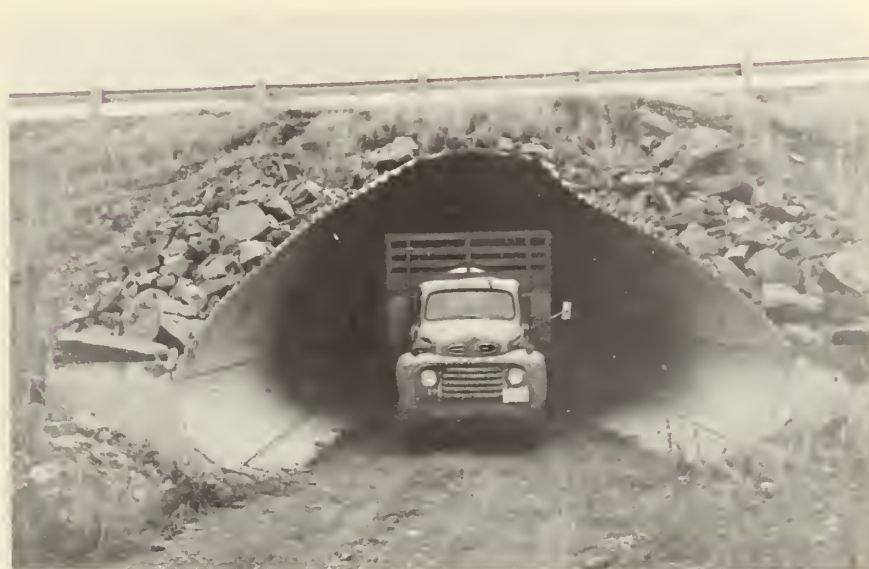
North End

20'7" x 13'2" x 210' long, squash C.M.P. One mile east of Ballantine under 4-lane I-94. Truck is 9' high x 8' wide. Erosion during periods of high runoff.

North End, Arrow Creek outlet
